A STUDY ON THE CAUSE OF KUKAR BRIDGE COLLAPSE

----- WHAT DOES IT TEACH IN MUSI I (AMPERA), II, III, IV? -----

By Prof. Dr. Sohei Matsuno at IBA University, Palembang, Indonesia

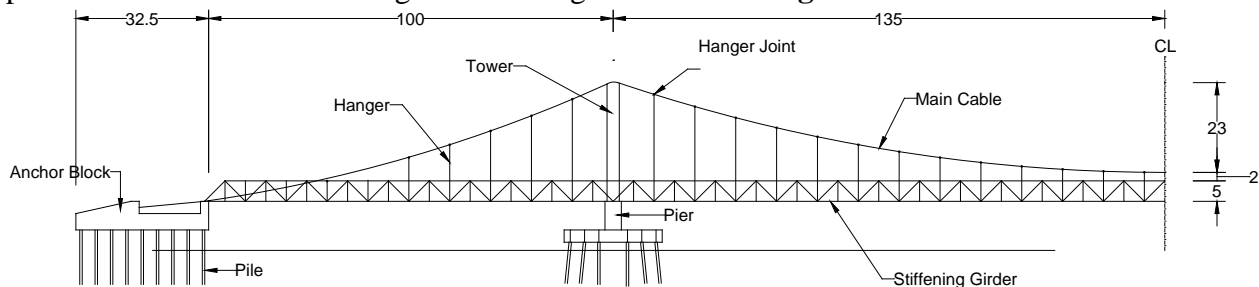
Fig 1 General view of Kukar Bridge

The Bridge is a 3-span continuous suspension type of 270 (main span) + 2@100 (side spans) = 470-m long, 9-m wide, 15-m HWS clearance, a pair of suspension towers of 30-m high above the clearance level and a through-type Warren truss stiffening girder of 5-m high suspended by a pair of main cables of 23-m sag with 92 hanger cables. See **Fig. 1**.

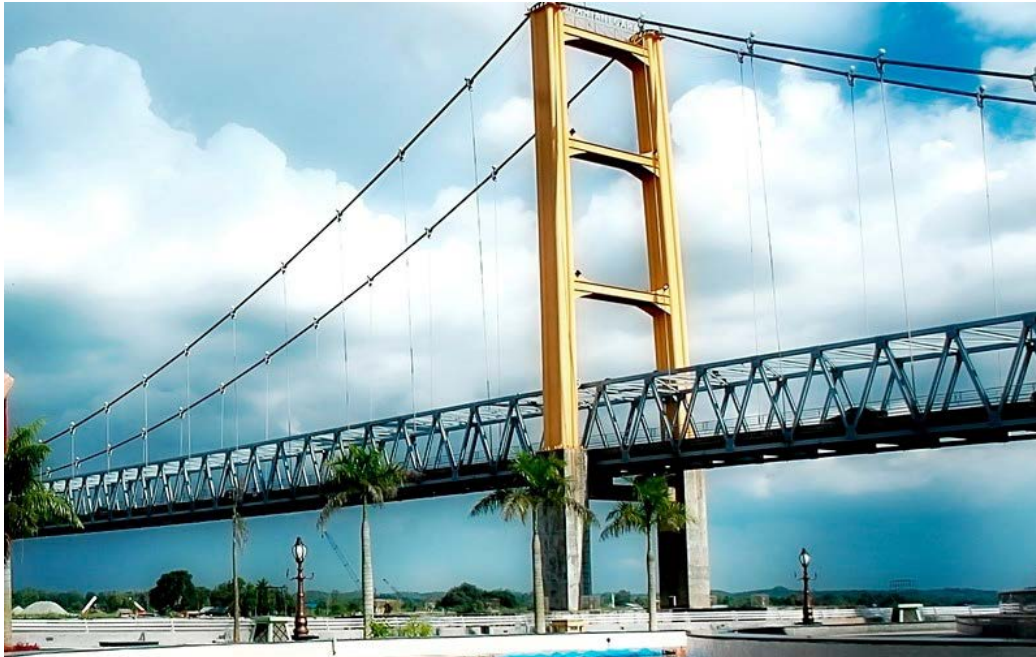
The last pre-collapse inspection in 2011 found three structural irregularities, viz. (i) the horizontal displacement of main cables' anchor blocks (10 cm), (ii) the inclination of towers (0.2°) towards the river and (iii) deflection of the stiffening girder deck (72 cm at the main-span

Photo 1 Kukar Bridge before collapse (Source IN, some signs of collapse are visible)

This was a direct effect of the above Item (1). The tower tops were practically fixed, hence, they were forced to move by 10 cm (towers inclined at 0.2°) towards the river (**Photo 1**).

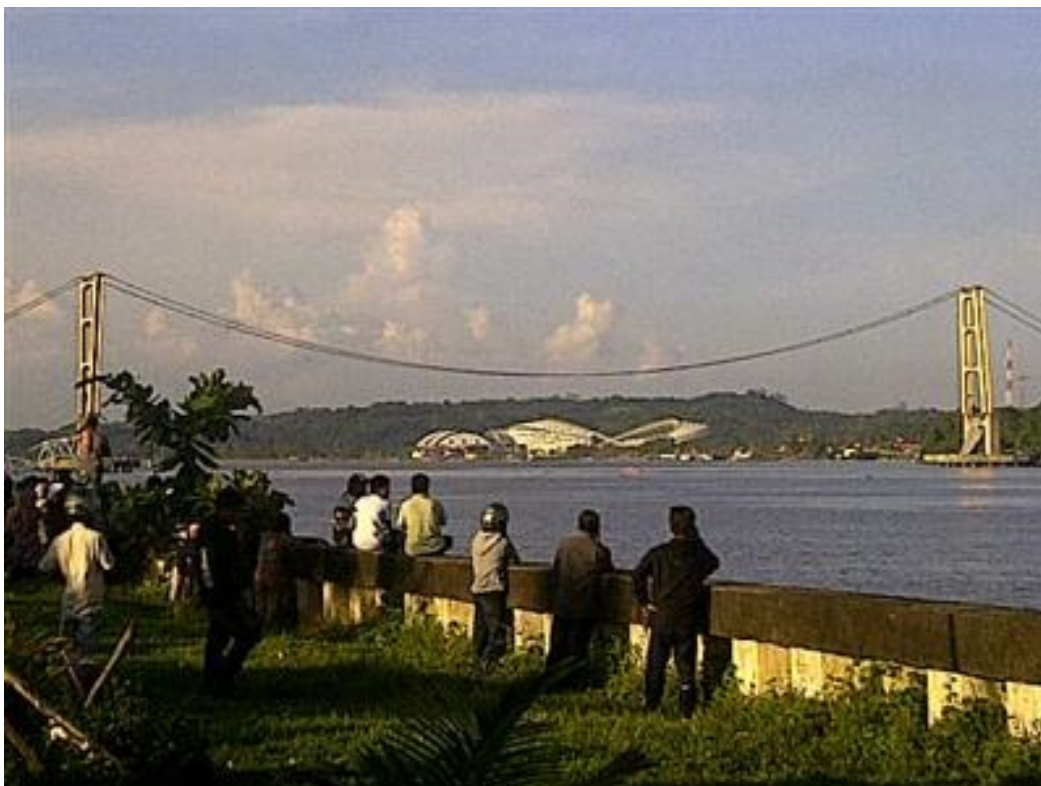
Photo 2 ditto after collapse (Source IN, no hanger remains)

Comment: if disconnection occurred at the lower joints with a deck (Priyo Suprobo 2011), the hanger cables must remain at the upper joints after the collapse. No hanger remains there.

- (1) The Bridge collapse happened when hanger cables disconnected at their upper joints. It's obviously proven by the fact that no hanger is left at the upper joints. The joined components shall not disconnect at the joint.

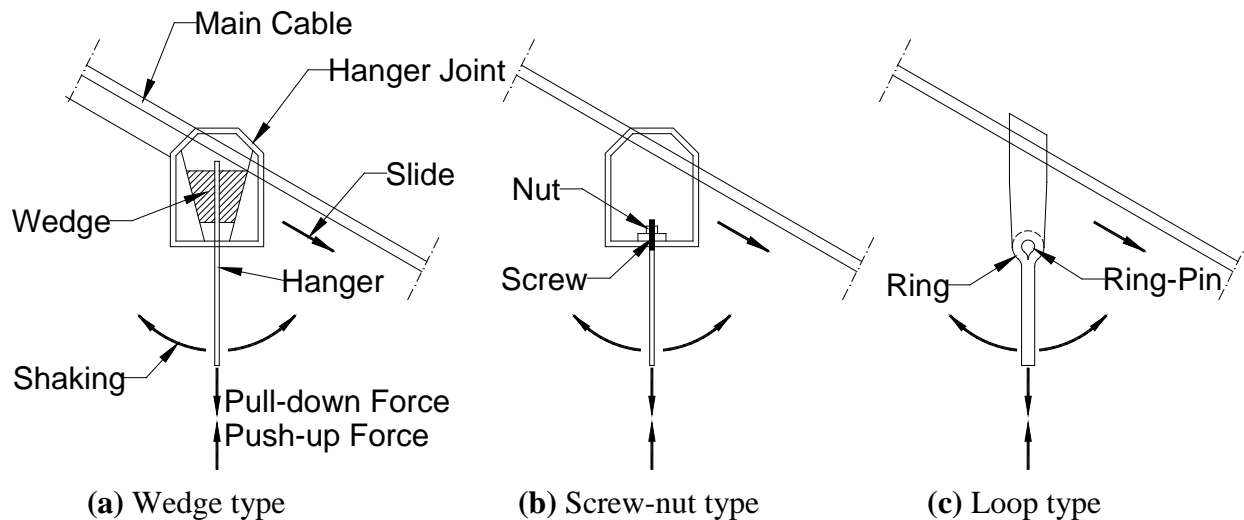
Fig. 3 Concept of three basic types of anchors

Despite writer's proposal, no data is given. Hence, it is unknown which type was used in the Bridge. As nut-tightening work at the sloped main cable EL is difficult, it's supposed that the upper joints were permanently fixed by type (a) and the lower joint with the stiffening-girder deck were by type (b).

The point in issue is the durability of these anchors. There can be seen in Photos a spherical counter weight at each upper joint (probably patented). Its function is unknown; however, if it'd have played any role in the joint system, it might have played a negative role in the stability of the joints due to its vibration. Type (a) and (b) had been tested in Japan undurable under alternating loading. The reliability of these types depends on the quality of cast steel. Unreliability of type (c) anchor with welded ring-pin had been already proven by the Plau Negara Bridge collapse (Matsuno S. 2004).

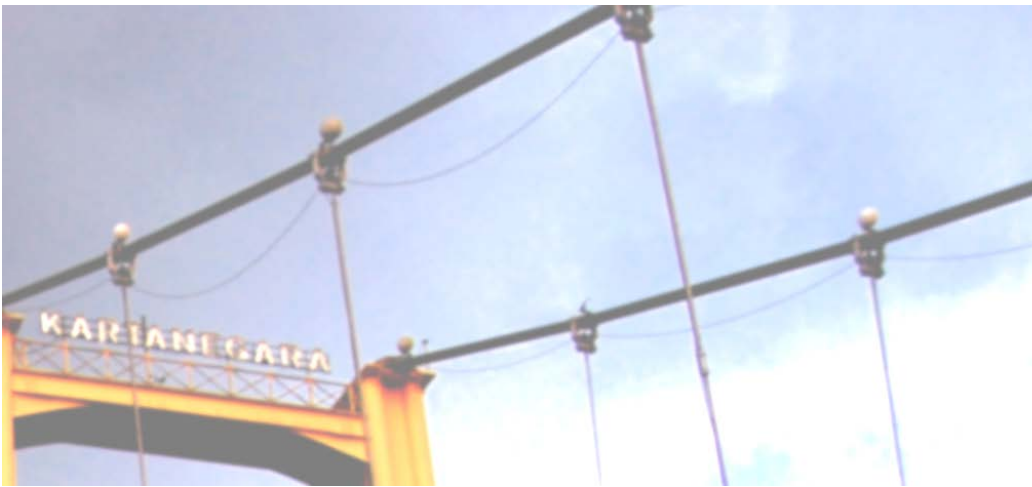
(a) Earlier

Kukar's joints' SF wasn't enough in both disconnection and sliding. See **Photo 3**.

The joints slid down along the main cables' slope. See **Photo 3**.

Photo 3 Joins before collapse (Note: unequal sags in inter-joint cables / unparallel hangers)

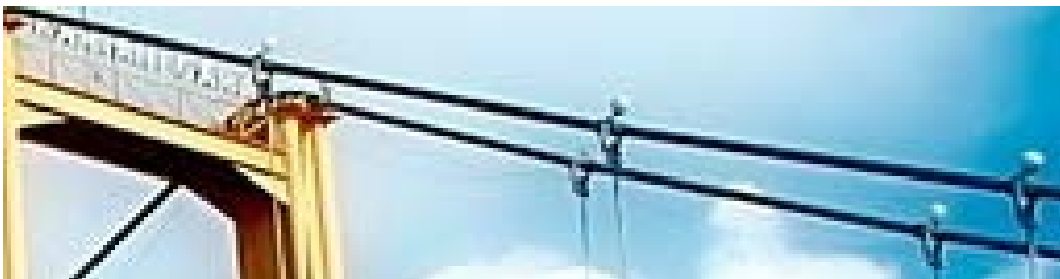
(b) Later

These were indirect effects of Item (1) and (2). The inclination of the towers increased the sagging of the main cables. It neutralized the tensile stress in hanger cables at near span centers. It caused the extra deflection of the stiffening girder, having transmitted the force from the near-span-center hangers to the near-towers hangers and the stiffening girder. As per writer's calculations, the cause of 72-cm deflection measured by the last inspection was 60 % of a main-cable-related origin, i.e., the displacement of main-cables' anchor blocks (50%), main cables' relaxation (5%), setting at their anchors (5%). The rest of 40 % was of a hanger-related origin, i.e., joints' sliding (15%), their plastic deformation /setting (20%) and hanger cables' relaxation (5%). See **Photo 3** and **4 (b)**
